TRANSPORTATION RESEARCH CENTER

ON-SITE AIR BAG FIRE INVESTIGATION

CASE NO. - 94-16
FLEET - PRIVATE VEHICLE
LOCATION - S [REDACTED], WISCONSIN
ACCIDENT DATE - [REDACTED] 1994

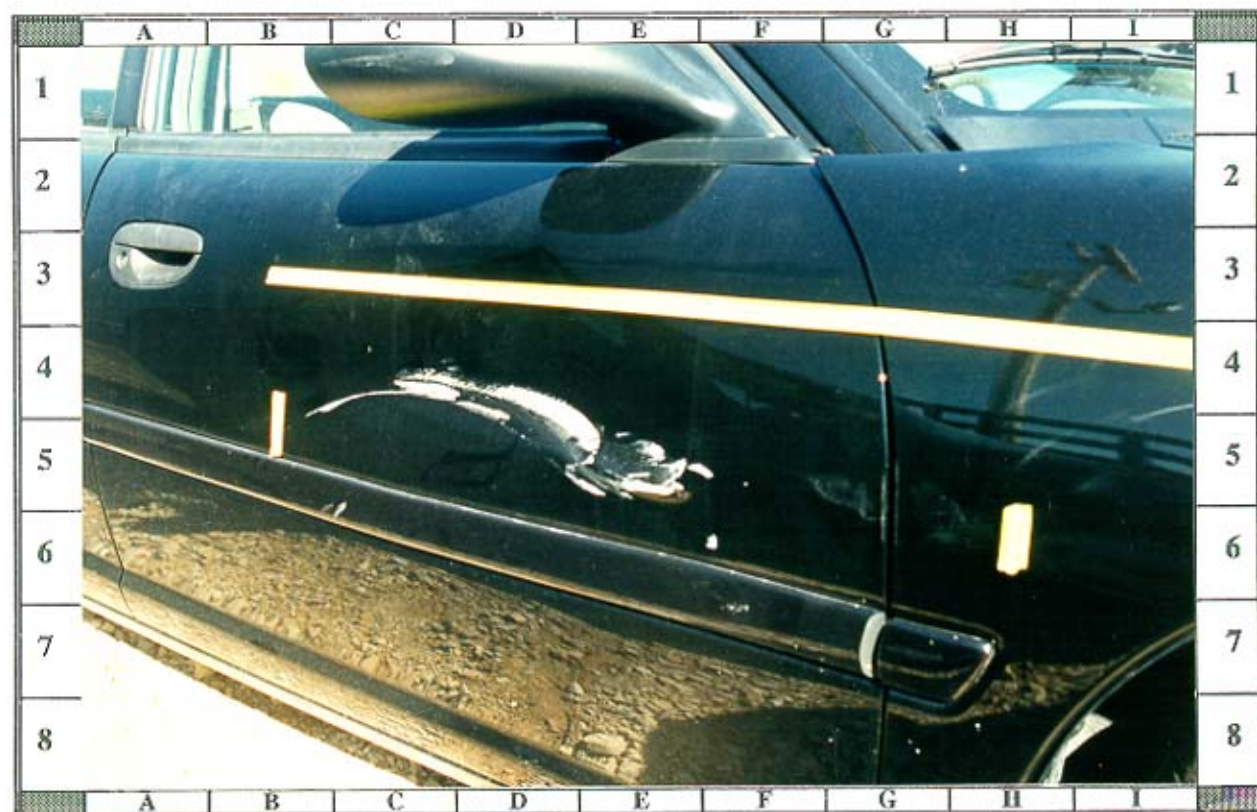
28 -- Close-up of sideslap damage to 1995 Plymouth Neon's right front door viewed from right rear

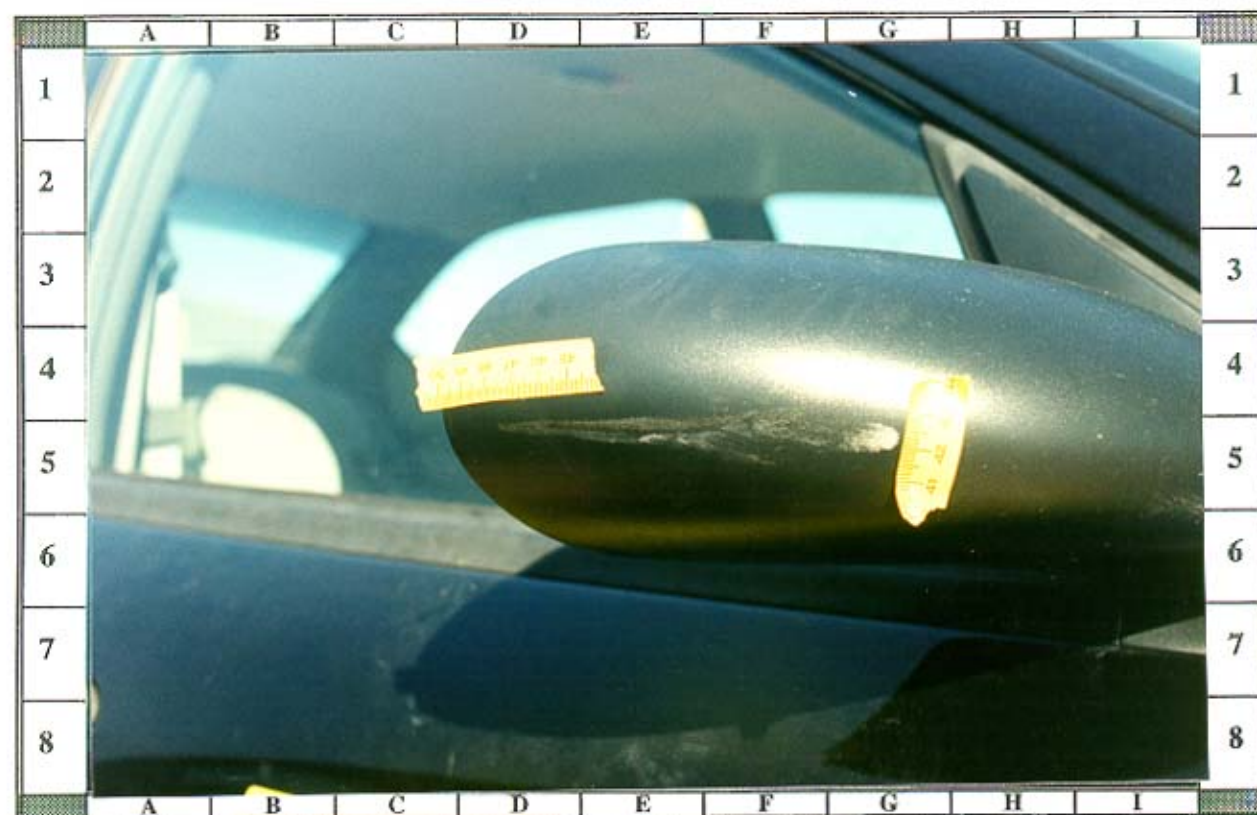
29 -- Close-up of sideslap damage to 1995 Plymouth Neon's right front door and rearview mirror (cells B1--C1) viewed from right front

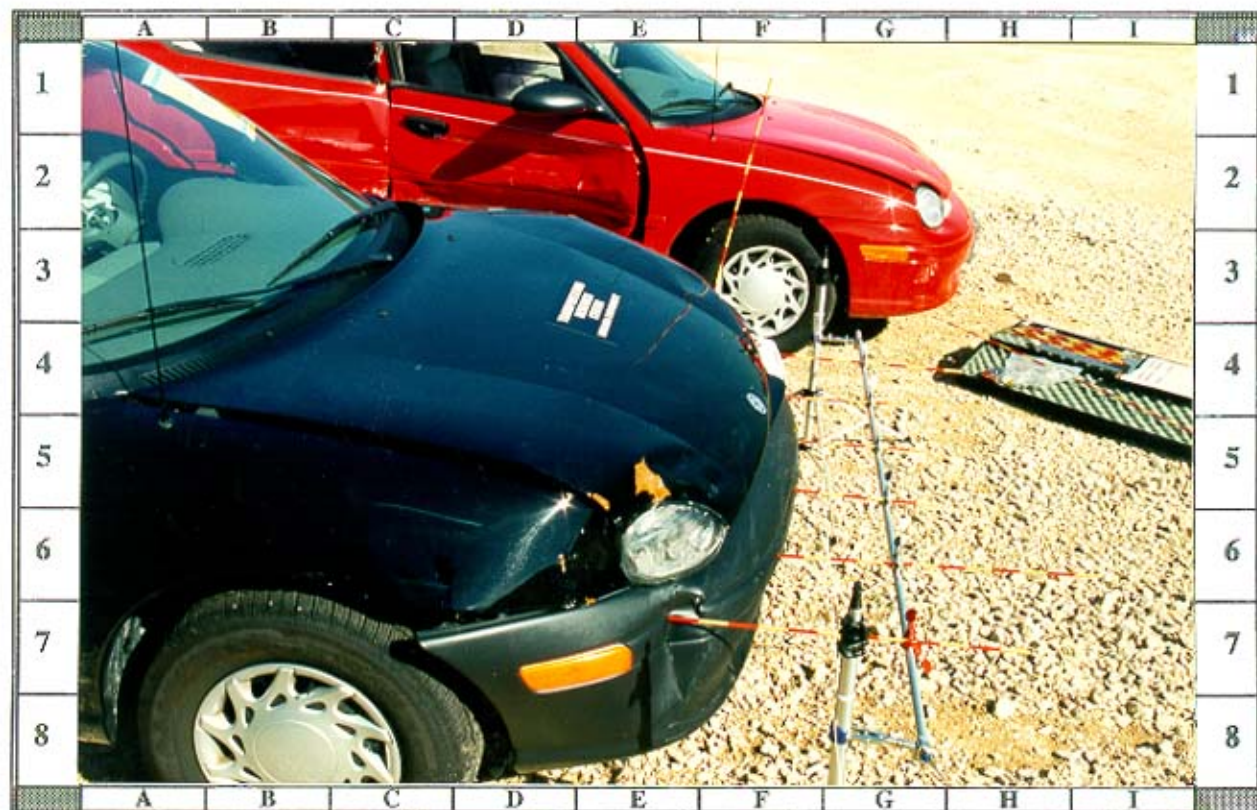
30 -- Closer-up of sideslap damage to 1995 Plymouth Neon's right outside rearview mirror viewed from right

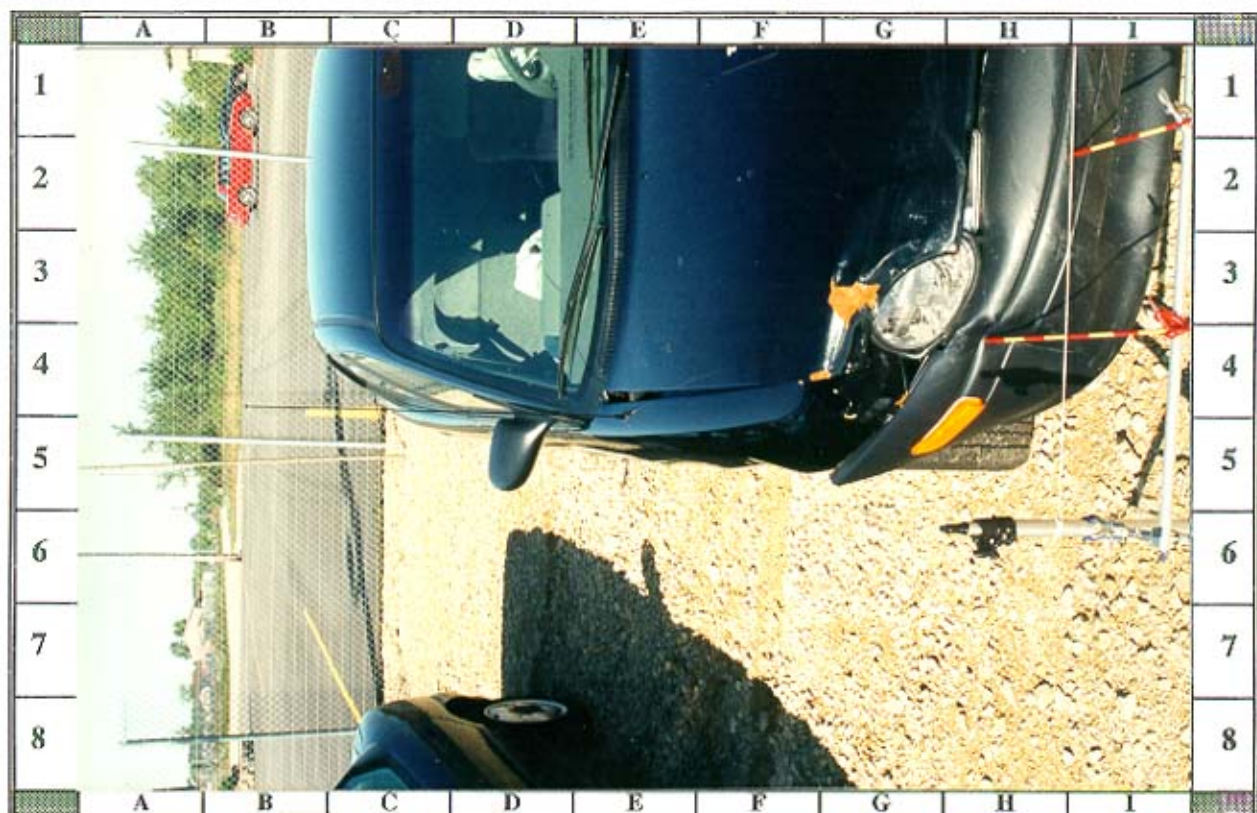
31 -- 1995 Plymouth Neon's frontal damage with contour guage present; viewed across front from right; NOTE: snag at RF bumper corner

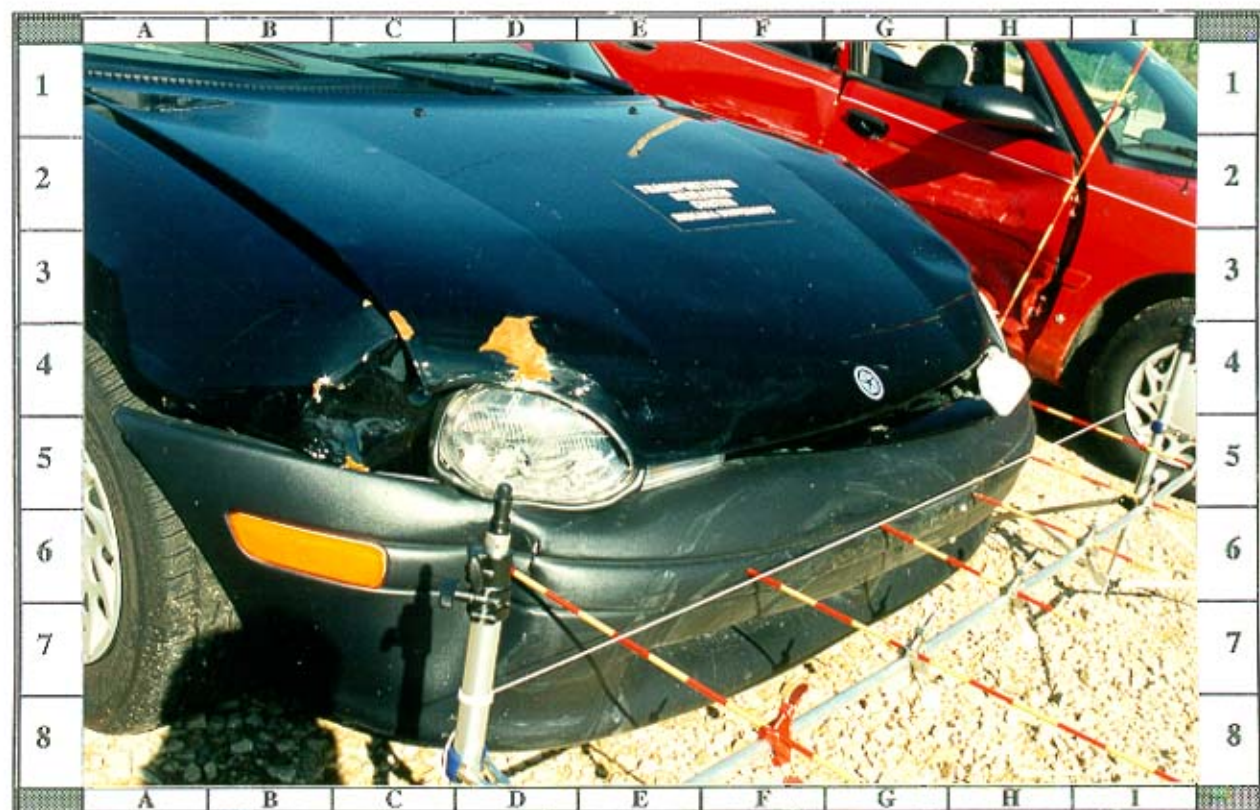
32 -- 1995 Plymouth Neon's right side viewed along right side from front; NOTE: damage to right headlight assembly and bumper snag

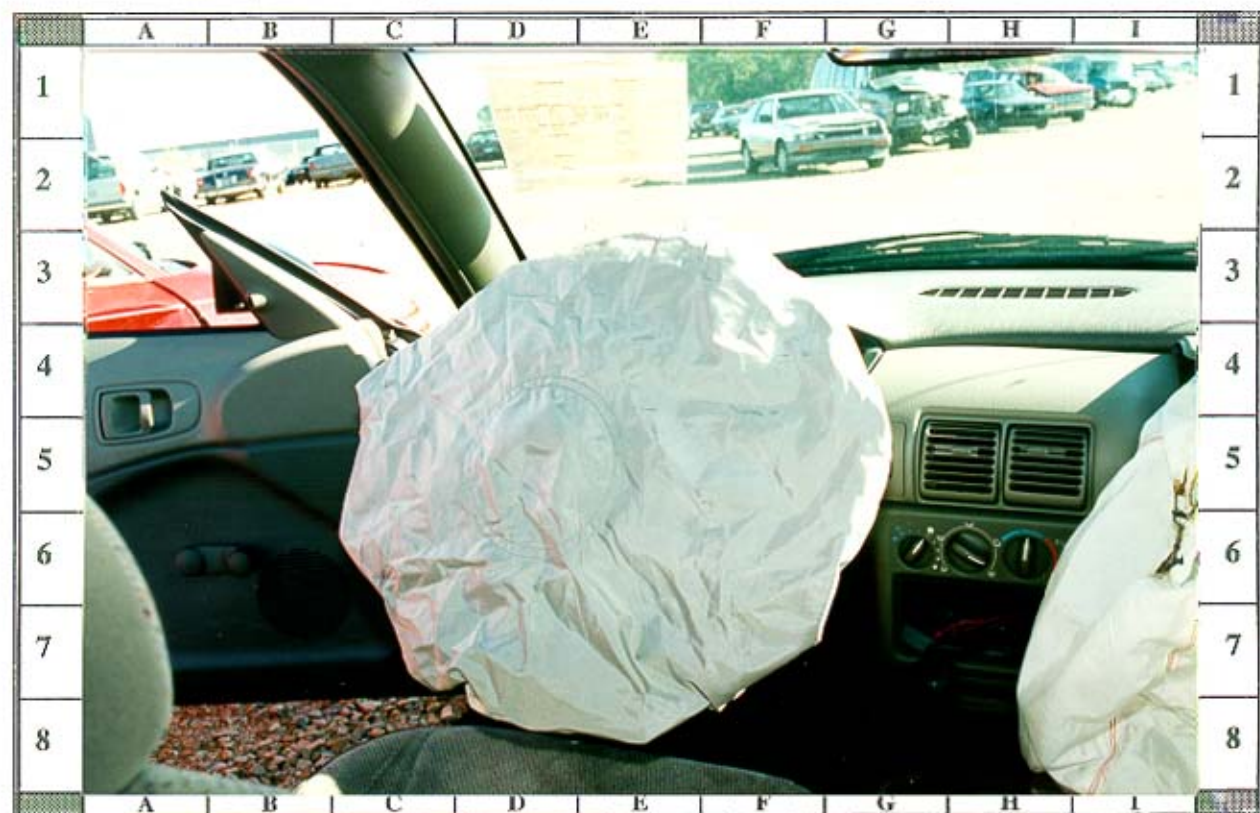
36 -- 1995 Plymouth Neon's driver side air bag, left A-pillar, forward L door surface, & center dash; NOTE: no contact evidence

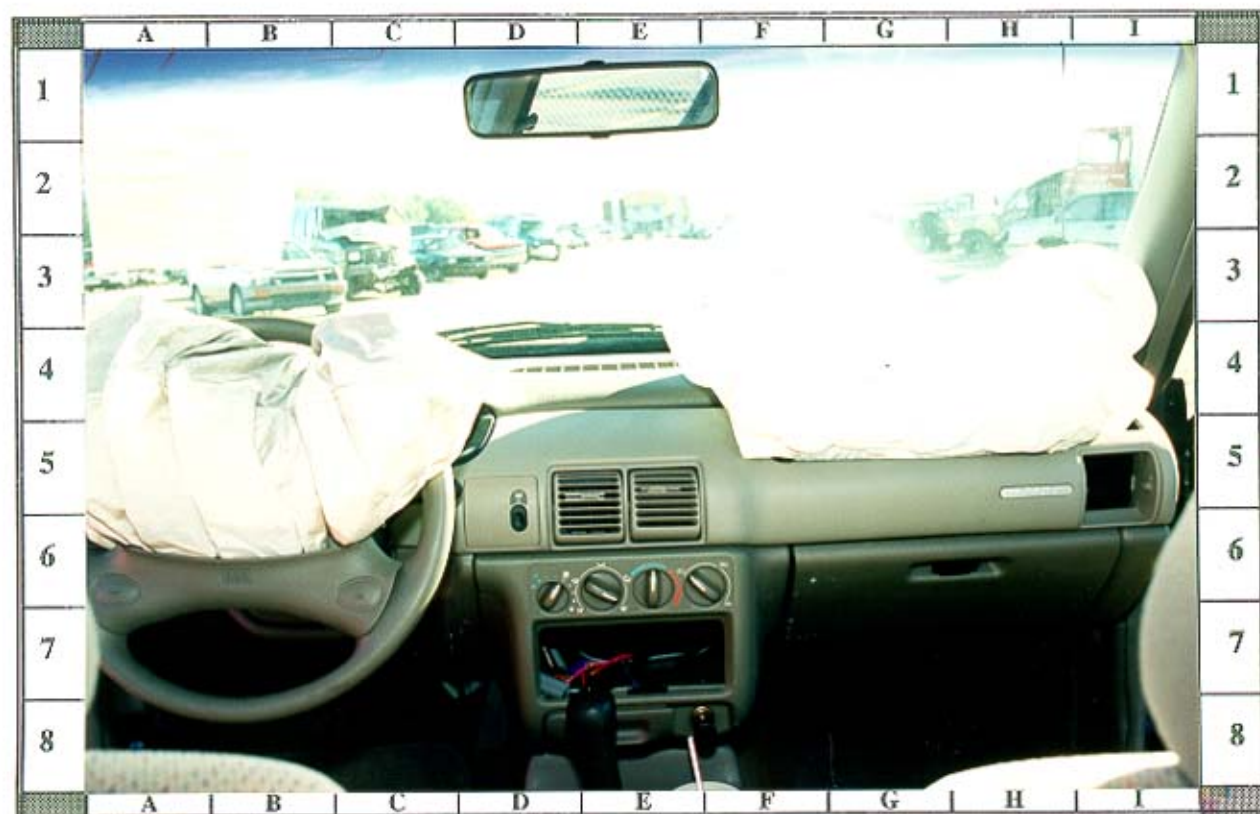
37 -- 1995 Plymouth Neon's lower steering wheel, mid & R dash, windshield, & rearview mirror; NOTE: no contacts & radio removed

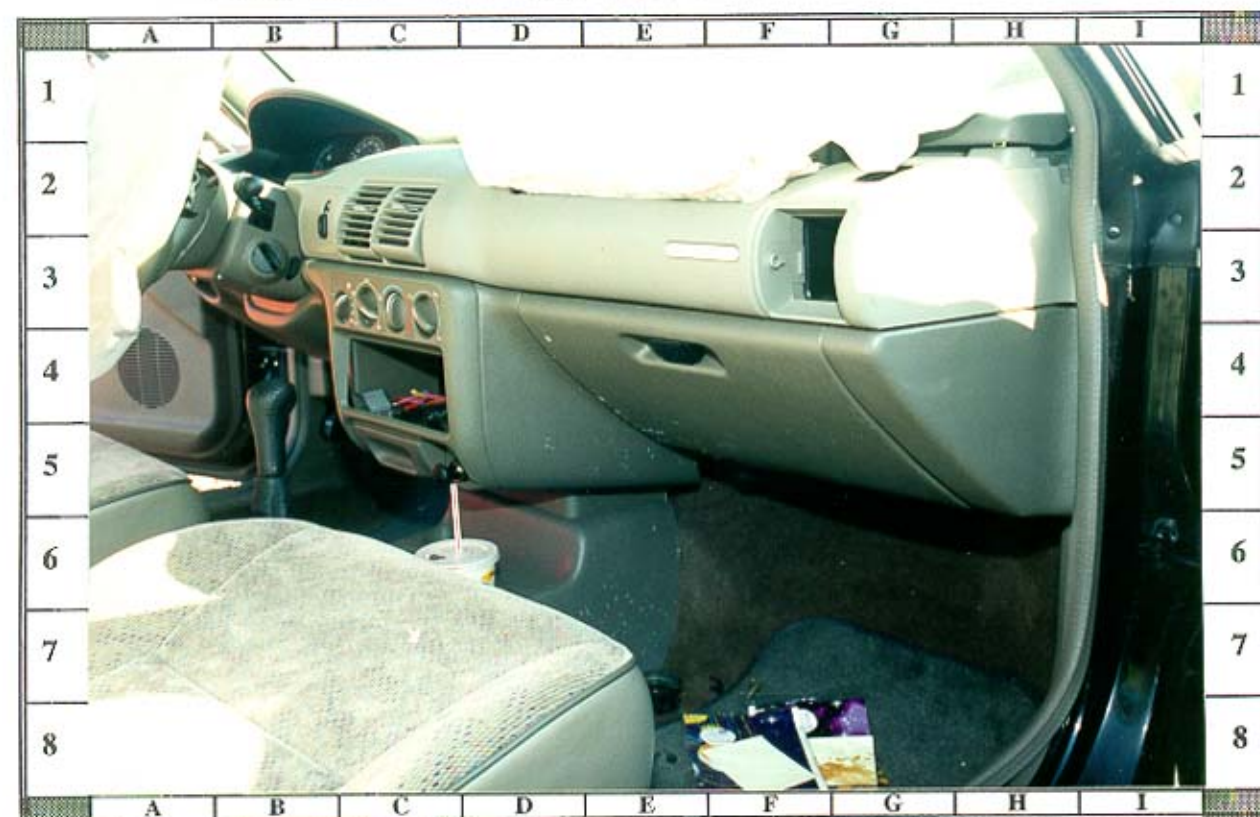
38 -- 1995 Plymouth Neon's middle and right dash and right toepan area viewed from right front door; NOTE: no contact evidence/radio

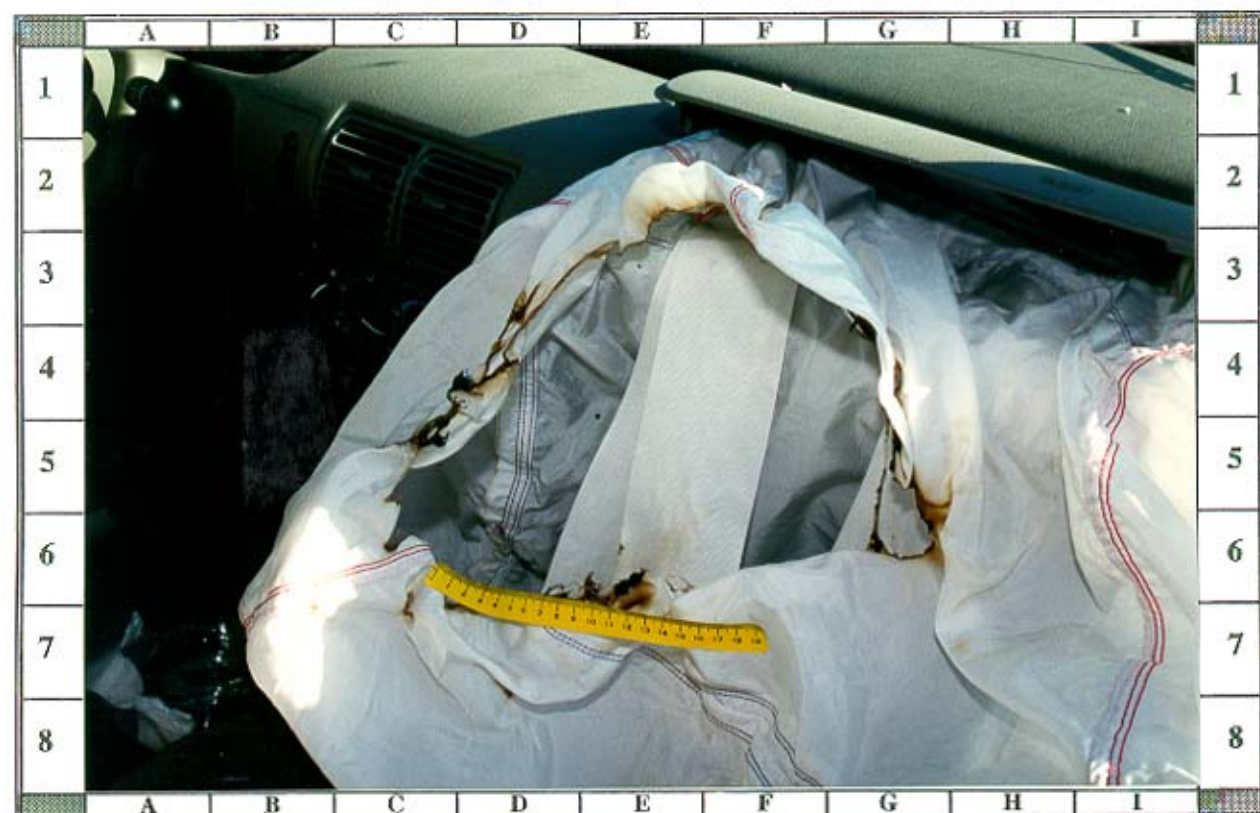
Concerning the post-deployment air bag fire, it must be noted that at no time was there any flame (fire) observed. The extreme heat from the exhaust cannister caused the surrounding air bag material to subsequently melt causing the excessive smoke reported by both drivers and fire personnel. No evidence of flame (fire) damage was found near the air bag, windshield, or dashboard areas during this contractor's vehicle inspection.

39 -- 1995 Plymouth Neon's right front passenger air bag showing large burn hole in air bag

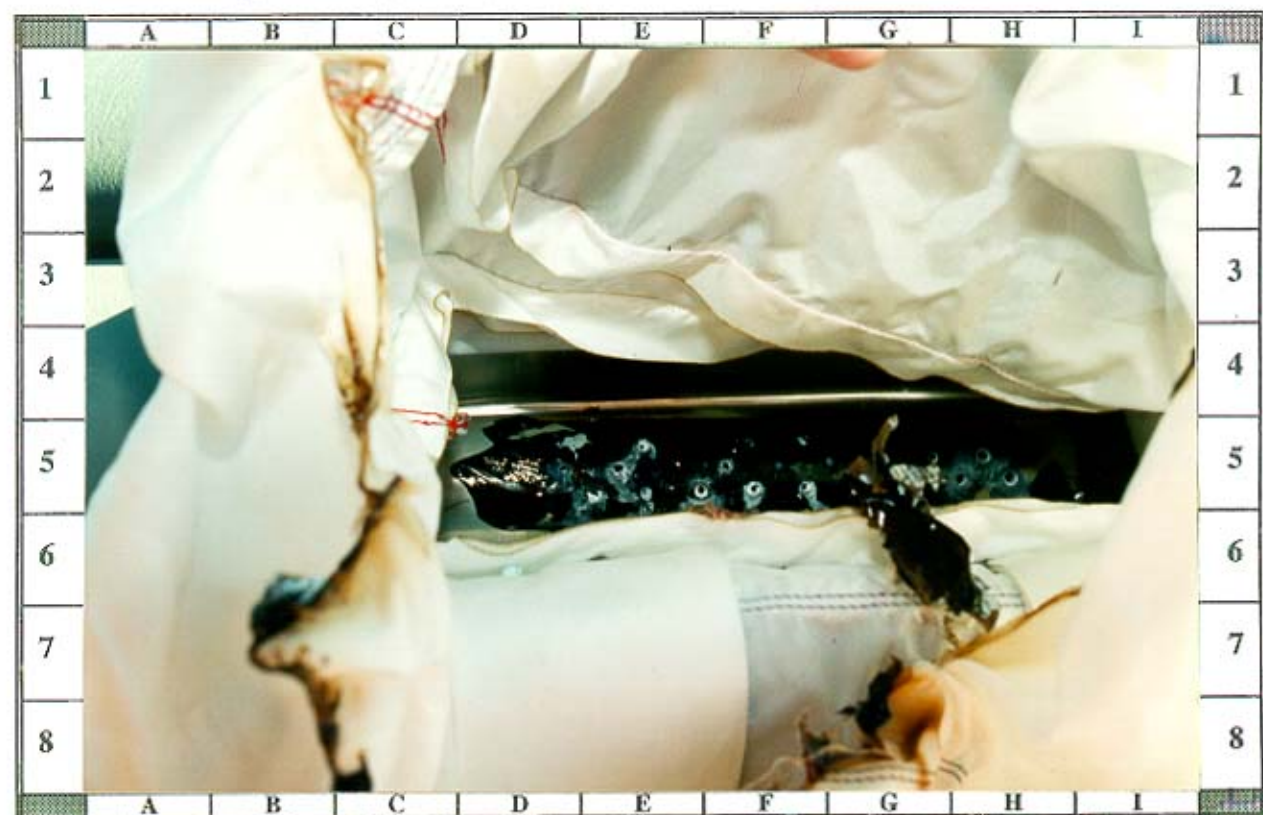
41 -- Close-up of burn mark on 1995 Plymouth Neon's right front passenger air bag tether; NOTE: burn marks around hole's periphery

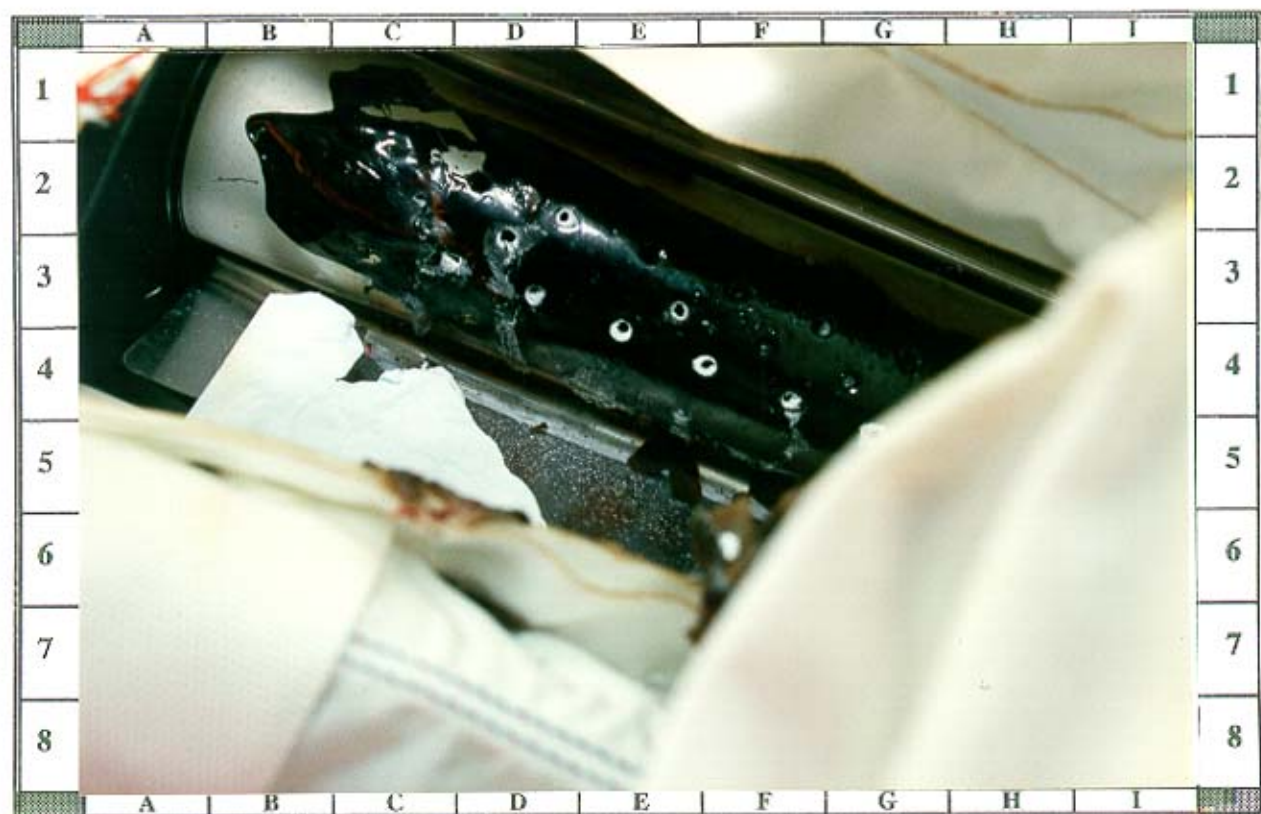
43 -- Close-up of 1995 Plymouth Neon's RF passenger air bag inflator assembly; NOTE: singed paper-like material next to inflator

45 -- Close-up of singed paper-like material found inside '95 Plymouth Neon's RF passenger air bag; see photo #43 above--cells B3--D5

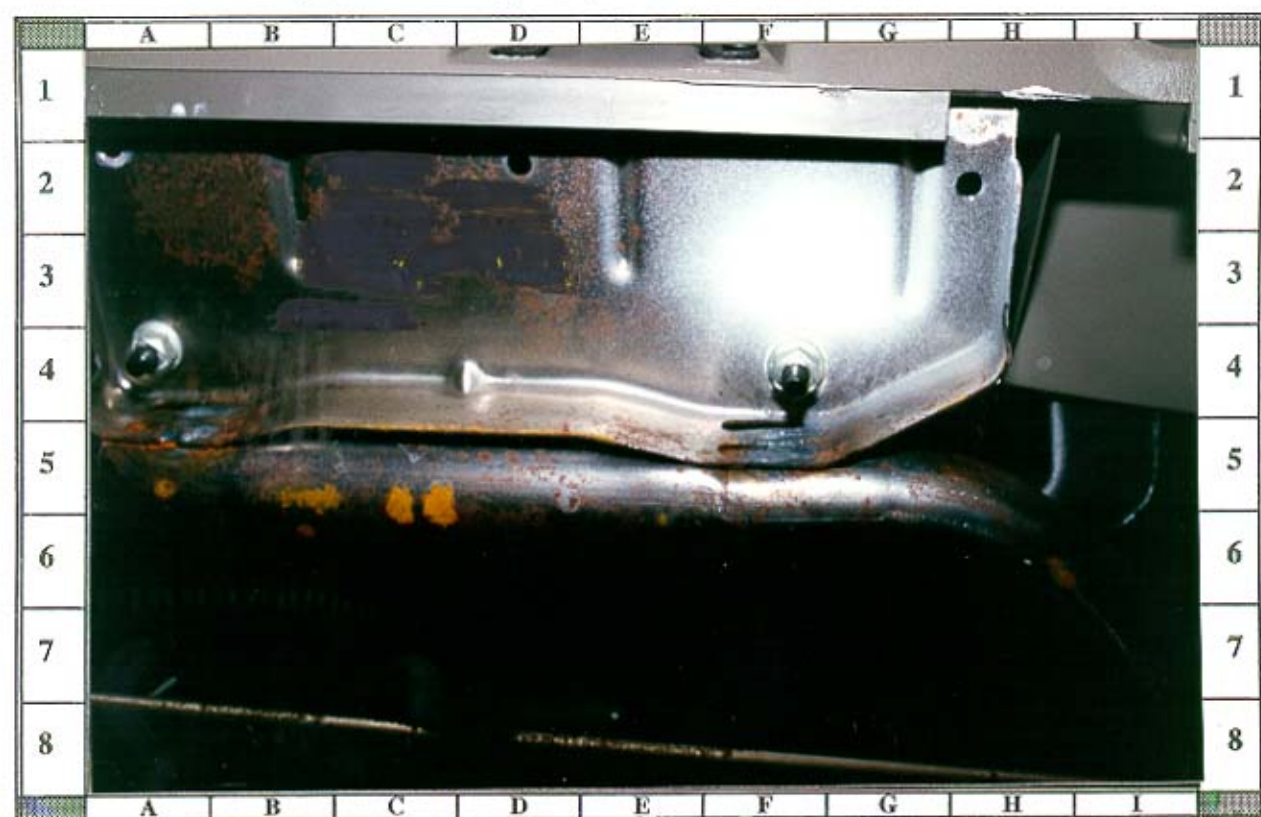
44 --- Close-up of 1995 Plymouth Neon's right front passenger air bag Reaction Can taken from underneath right front dash

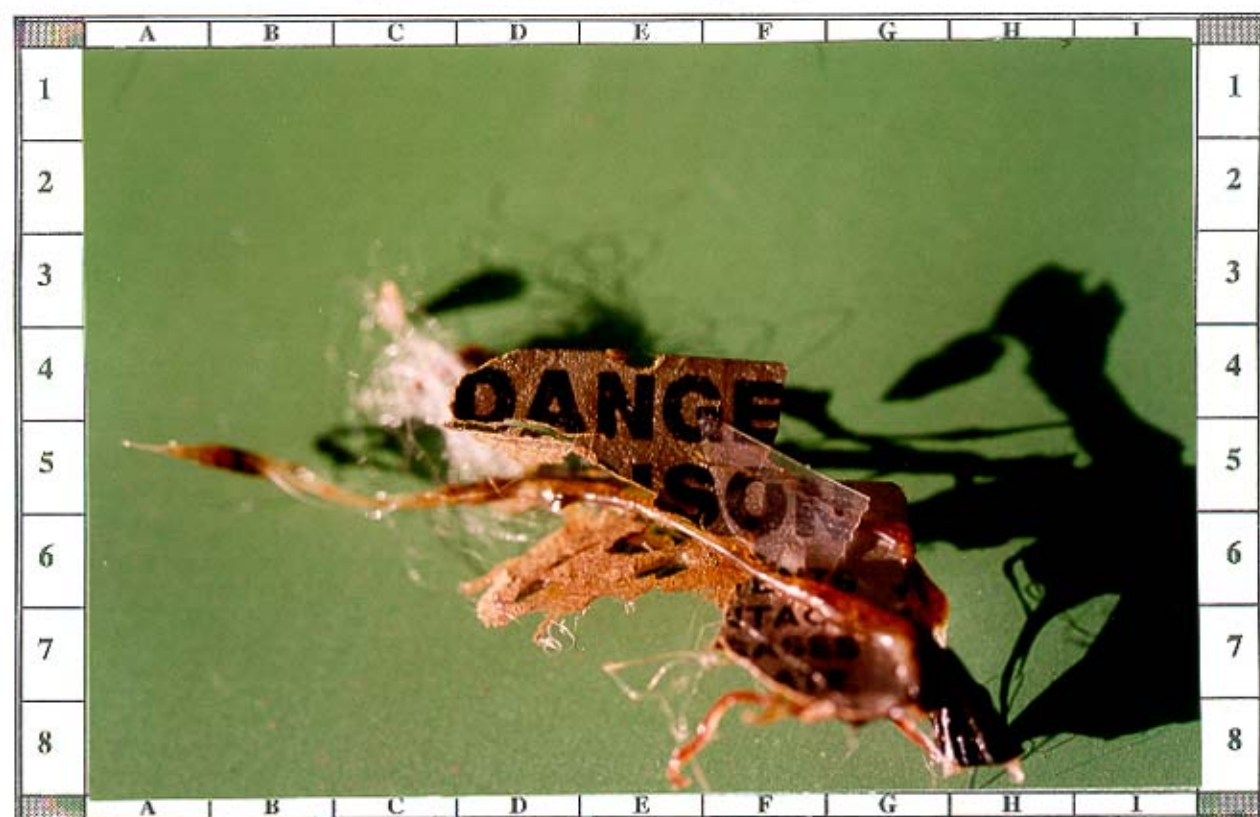
47 -- Close-up of warning label attached to melted material found inside 1995 Plymouth Neon's RF air bag; see photo #42 cells F5--G5

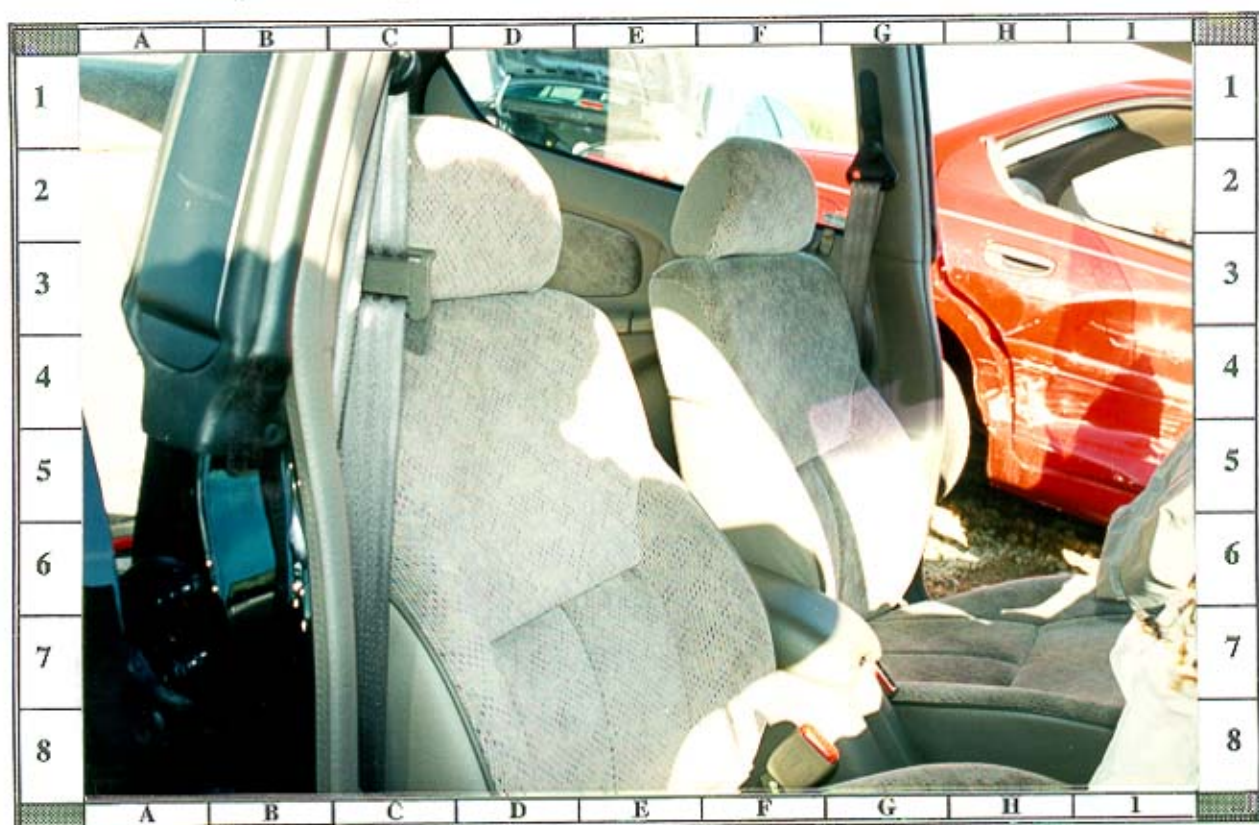
51 -- Undamaged deployed right front passenger air bag found in an exemplar 1995 Plymouth Neon which was located in same salvage yard

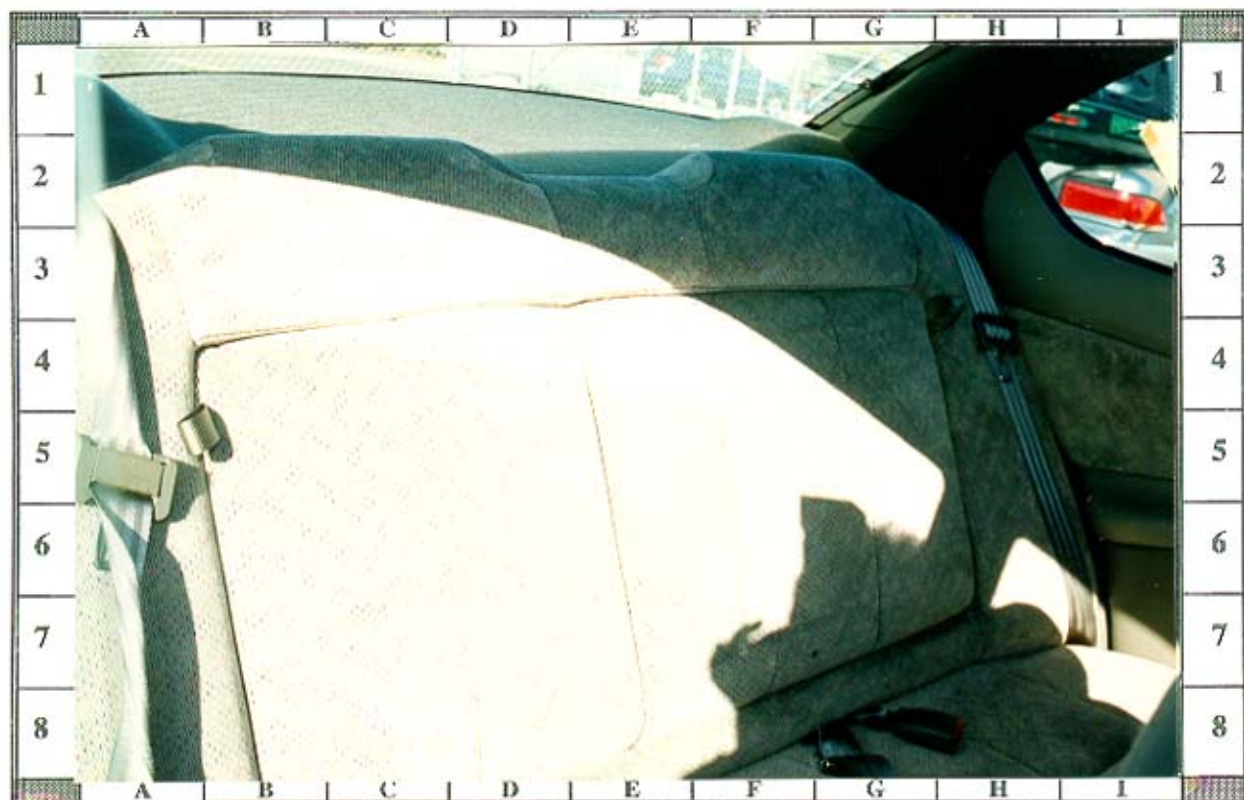
53 -- Interior view of 1995 Plymouth Neon's rear seatbacks and active three-point restraints for rear outboard passengers

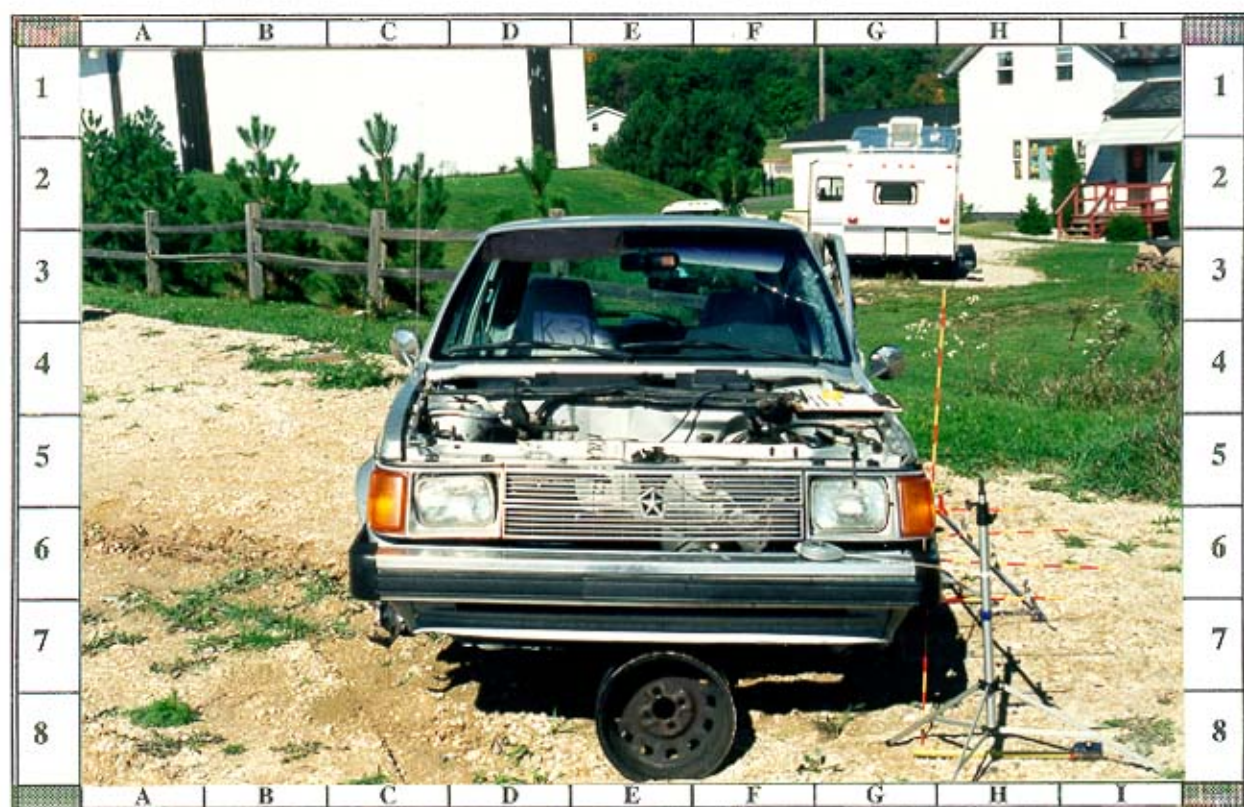
54 -- 1986 Dodge Omni's undamaged front viewed from front; NOTE: engine, hood, and both front wheels have been removed

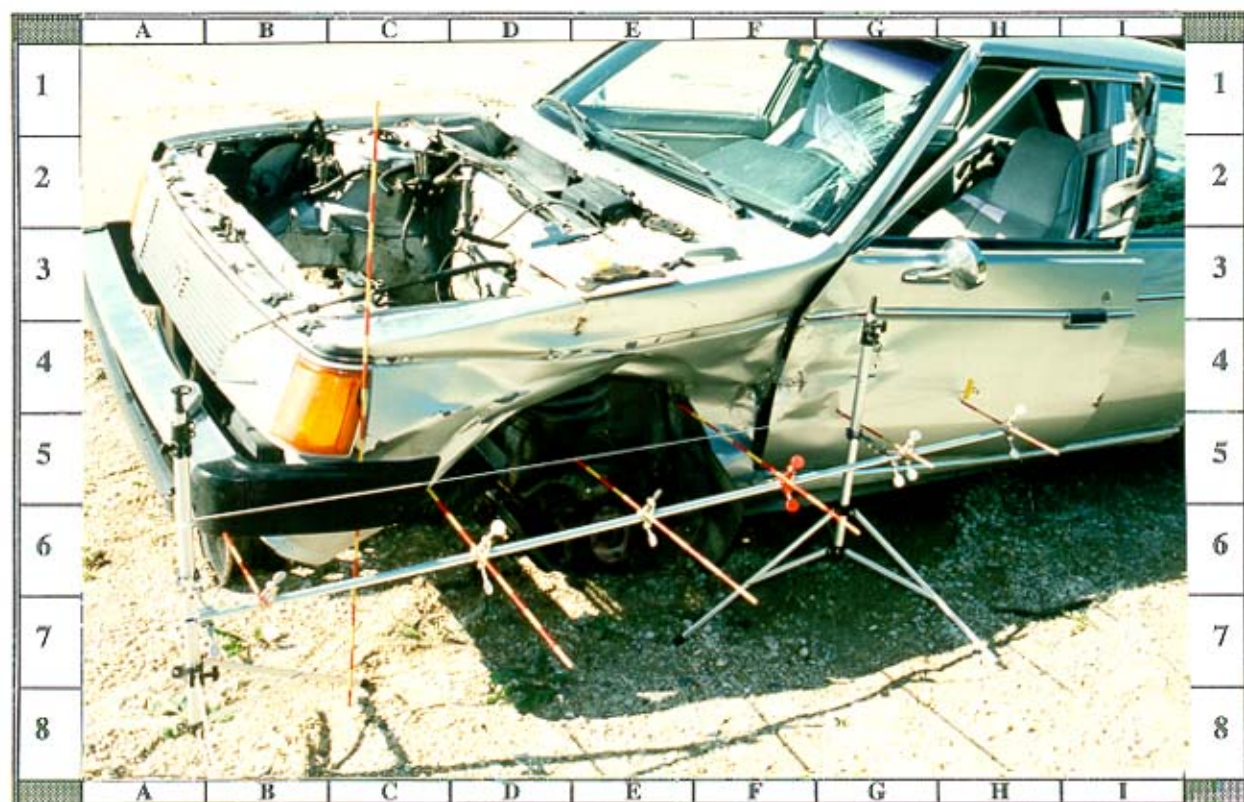
55 -- 1986 Dodge Omni's left front direct damage with contour gauge present viewed from left front; NOTE: engine removed

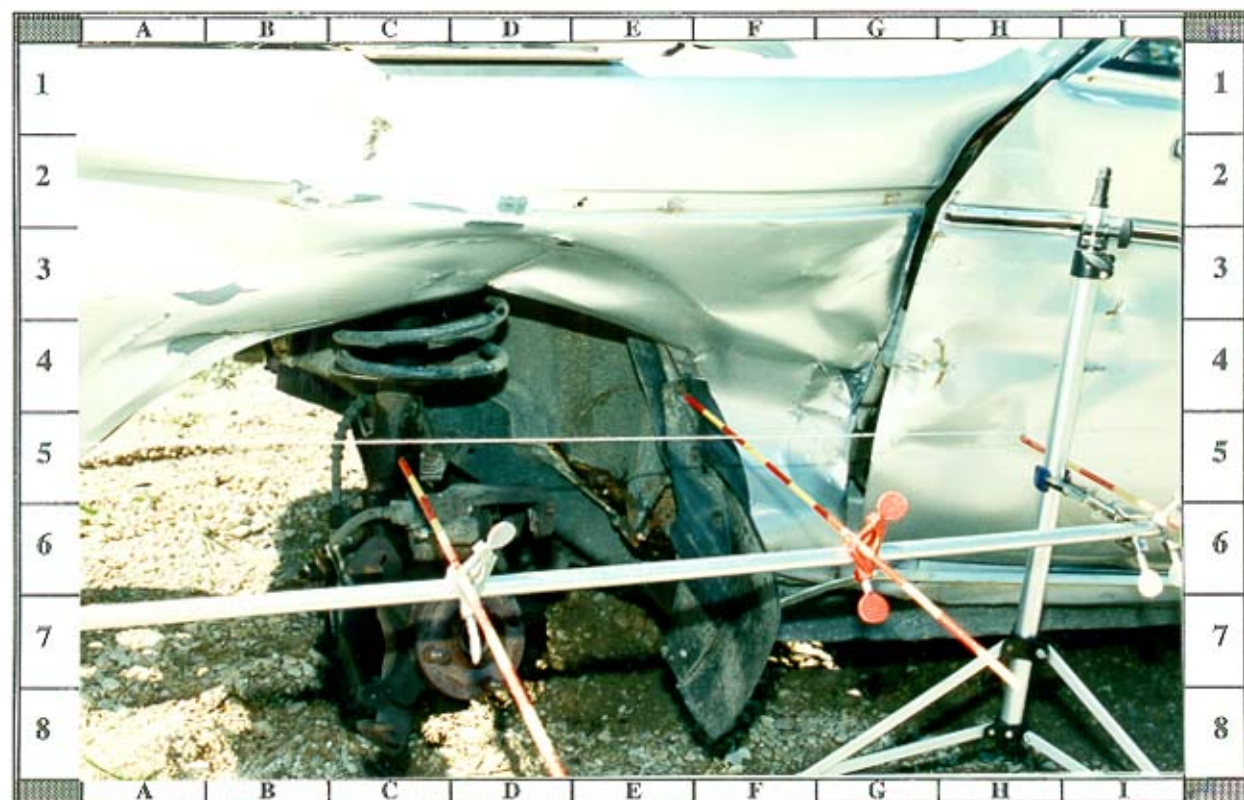
56 -- 1986 Dodge Omni's left front direct damage with contour gauge present viewed from left; NOTE: front tires removed

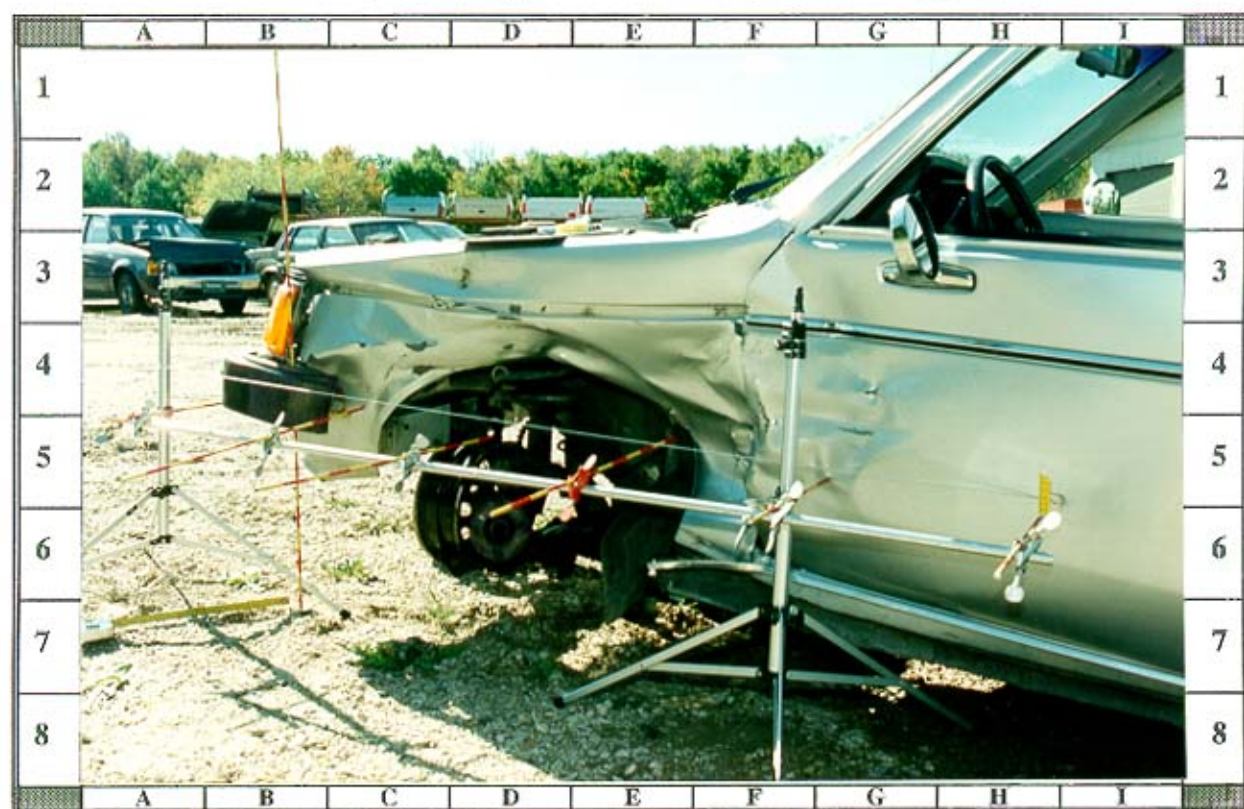
57 -- Close-up of 1986 Dodge Omni's left front damage at area of maximum crush (red clamp); NOTE: wheels gone and snagging near door

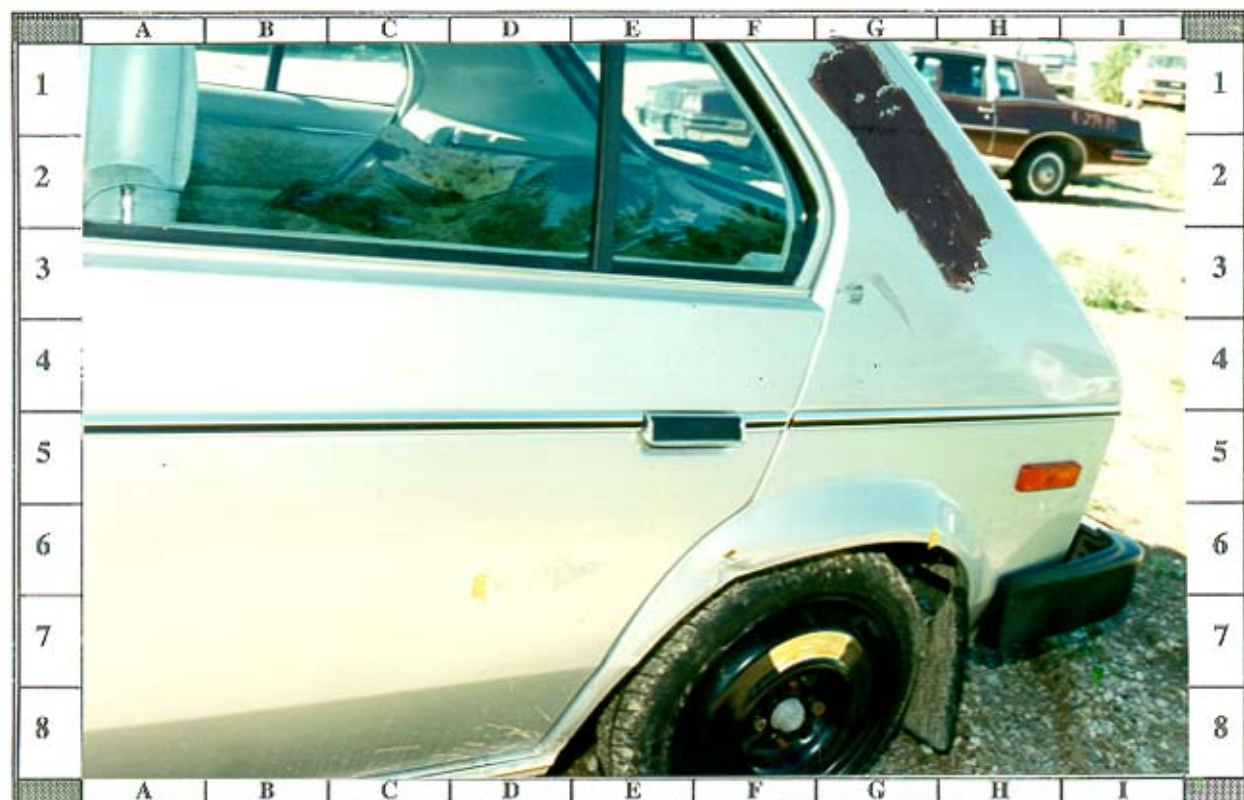
58 -- 1986 Dodge Omni's left front damage with contour gauge present viewed from left rear; NOTE: outside rearview mirror is intact

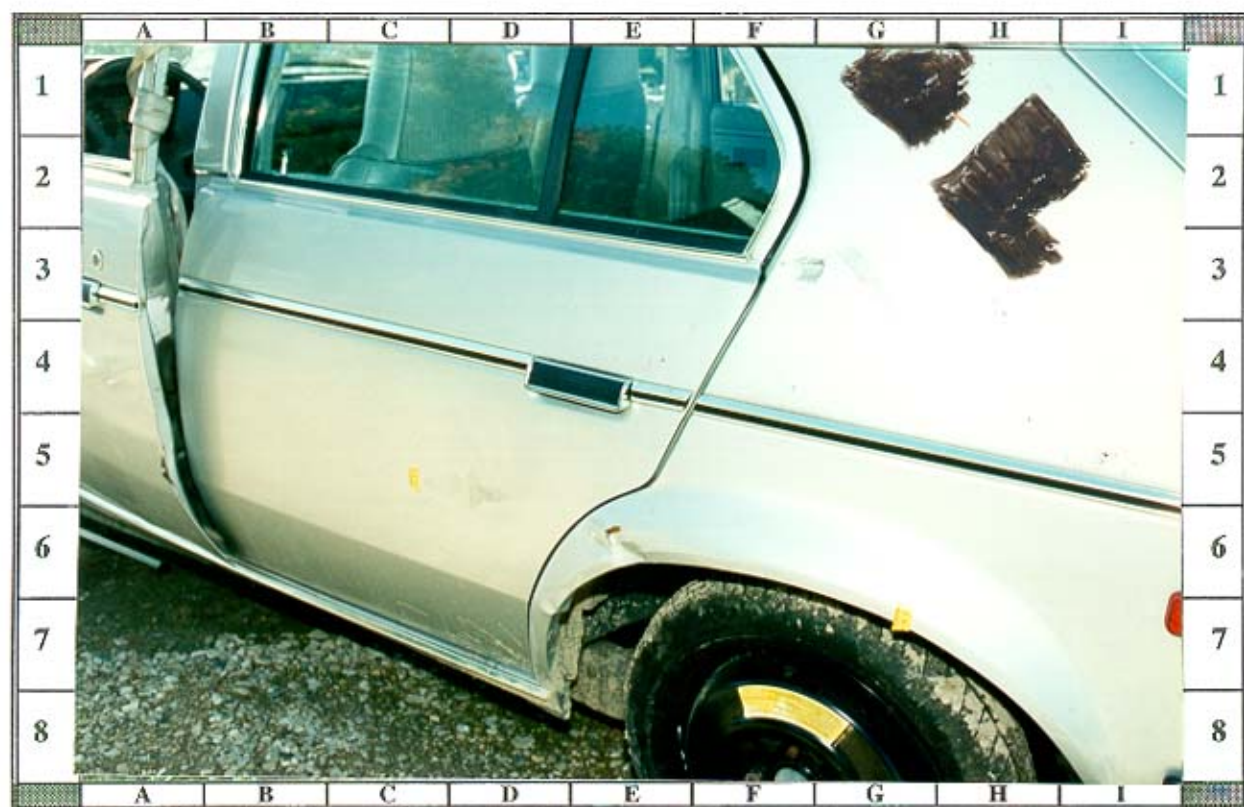
59 -- 1986 Dodge Omni's sideslap damage to left rear door and quarter panel viewed from left front

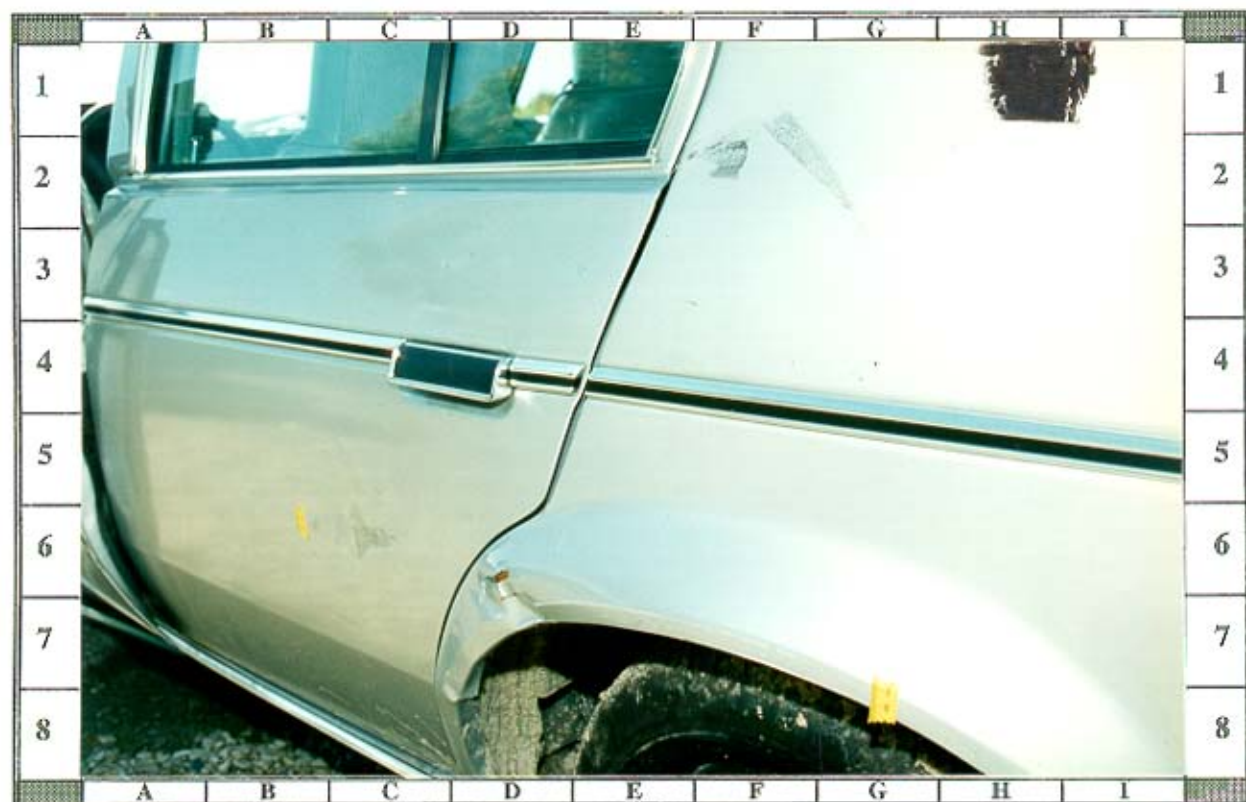
60 -- 1986 Dodge Omni's sideslap damage to left rear door and quarter panel viewed from left rear
